DAMAGE SURVEY REPORT (DSR)
Emergency Watershed Protection Program – Recovery

DSR Number: 019-05-065R Project Number: W-30 Main (Tributary of Houston River)

Drainage Name: W-30 Main (Tributary of Houston River) Reach: W-30 above confluence with Houston River (GPS point -Cypress Lat) and continuing upstream to Hwy 27.

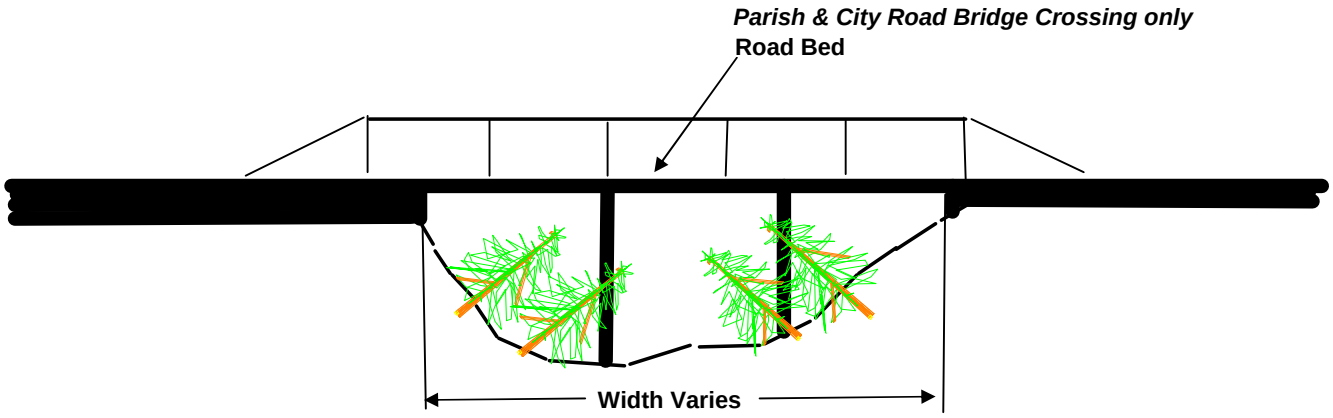
Typical Road Bridge Crossing
Not to Scale

Note: Contract is to remove Debris from upstream and downstream Bridge which includes underside of bridge
Exception: All Crossing which cross State or Federal highways are not included in contract

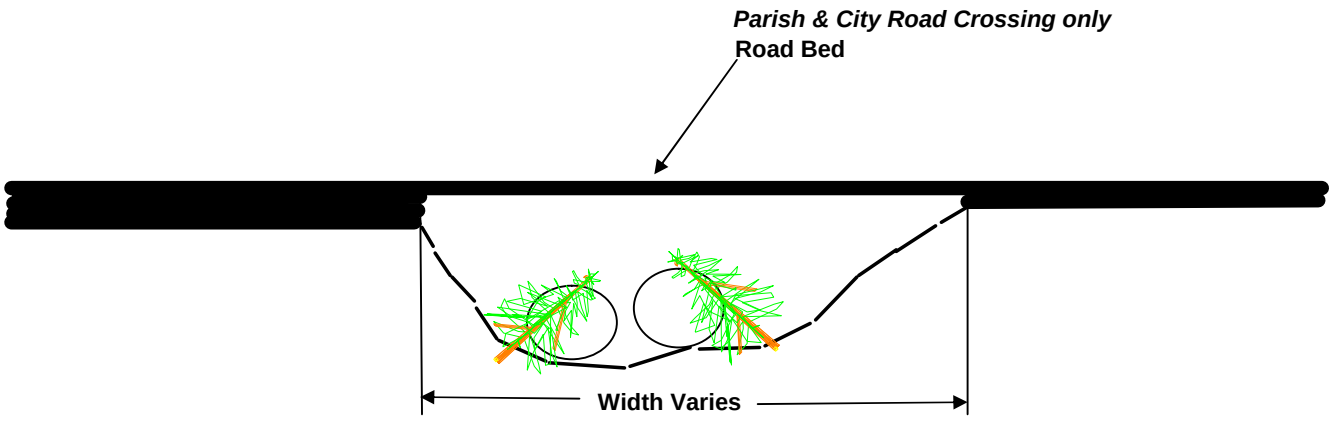
Typical Road Culvert type Crossing
Not to Scale

Note: Contract is to remove Debris from upstream and downstream Culverts which includes inside of culverts
Exception: All Crossing which cross State or Federal highways are not included in contract

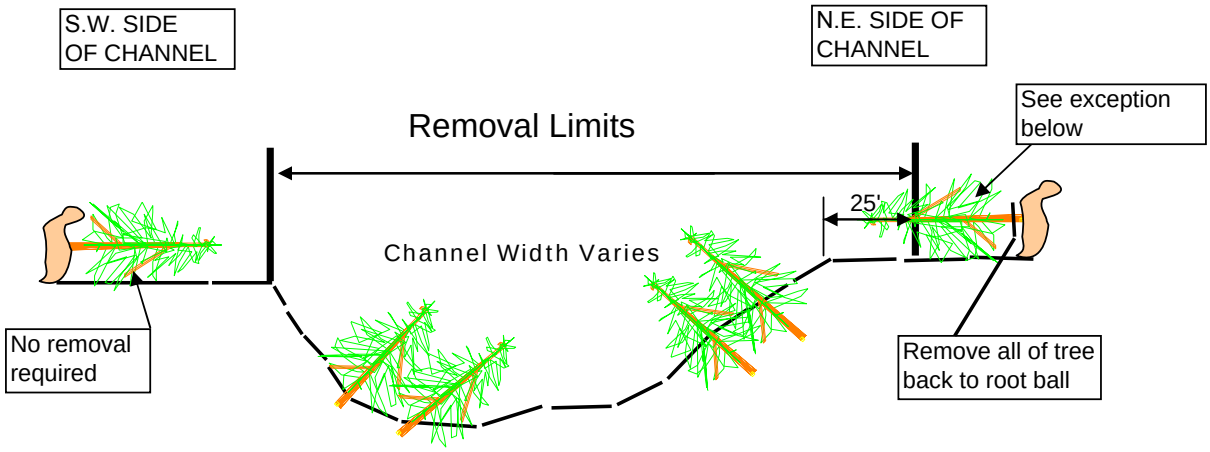
Typical Section (not to scale)

***Note** : Access and work from north & east side only, except in locations where structures do not permit as concurred in by the COTR*

***Exception** it may be possible that trees which were located outside of the the removal limits may have fallen into the removal limits, the entire tree will be removed back to the root ball even if only a portion of the tree is withinthe removal limits*
